Motorcoach Collision
With Crash Attenuator in Gore Area
US Highway 101
San Jose, California
January 19, 2016

Accident Report

NTSB/HAR-17/01
PB2017-101430

**National
Transportation
Safety Board**

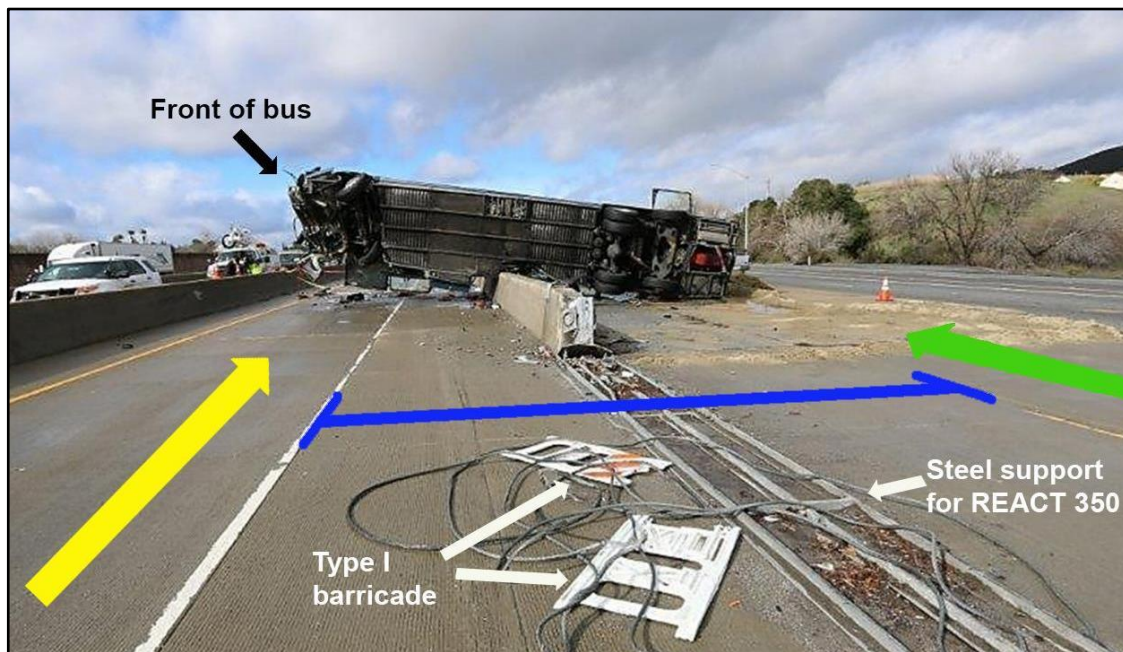
Figure 3. At-rest position of bus atop concrete barrier, straddling left exit HOV lane for SR-85 (yellow arrow) and US-101 HOV lane at right (green arrow). Depicted are: (a) steel plate in front of concrete barrier, which supported REACT 350 crash attenuator; (b) blue line marking width of gore (22 feet at this location); and (c) type I barricade, which was not visible to driver at time of crash. (Source: California Highway Patrol)

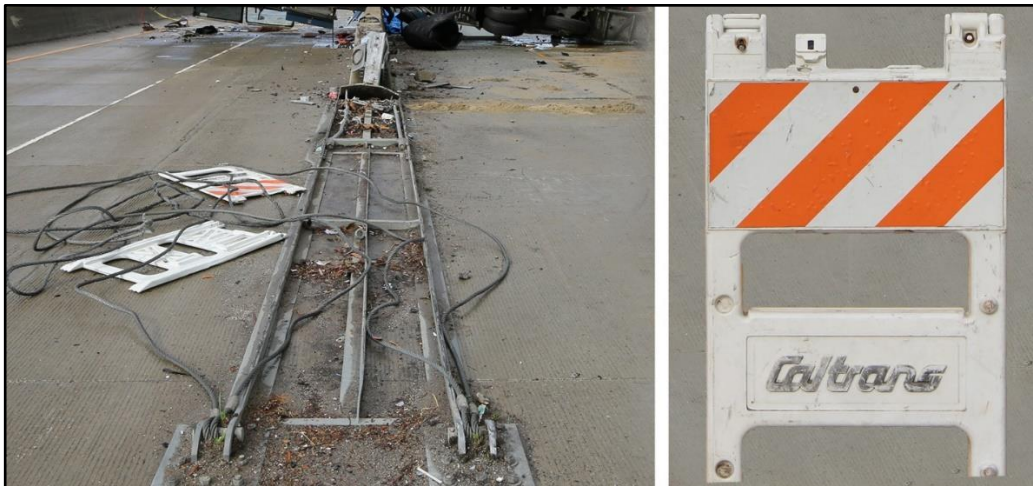
Figure 5. Displaced type I barricade in front of crash attenuator and next to steel support plate (left), and example of Caltrans type I barricade (right).

Based on evidence from the forward-facing DriveCam camera on the bus (see section 1.6.5), at the time of the crash, in the early morning of January 19, 2016, the type I temporary barricades did not delineate the crash attenuator. They were not visible to the driver.²⁰ After the crash, one barricade was located to the side of the steel support for the crash attenuator (see figure 5); and the other was found in the US-101 HOV lane, about 20 feet west–northwest of the final rest position of the bus. Caltrans has no policy for inspecting temporary barricades.

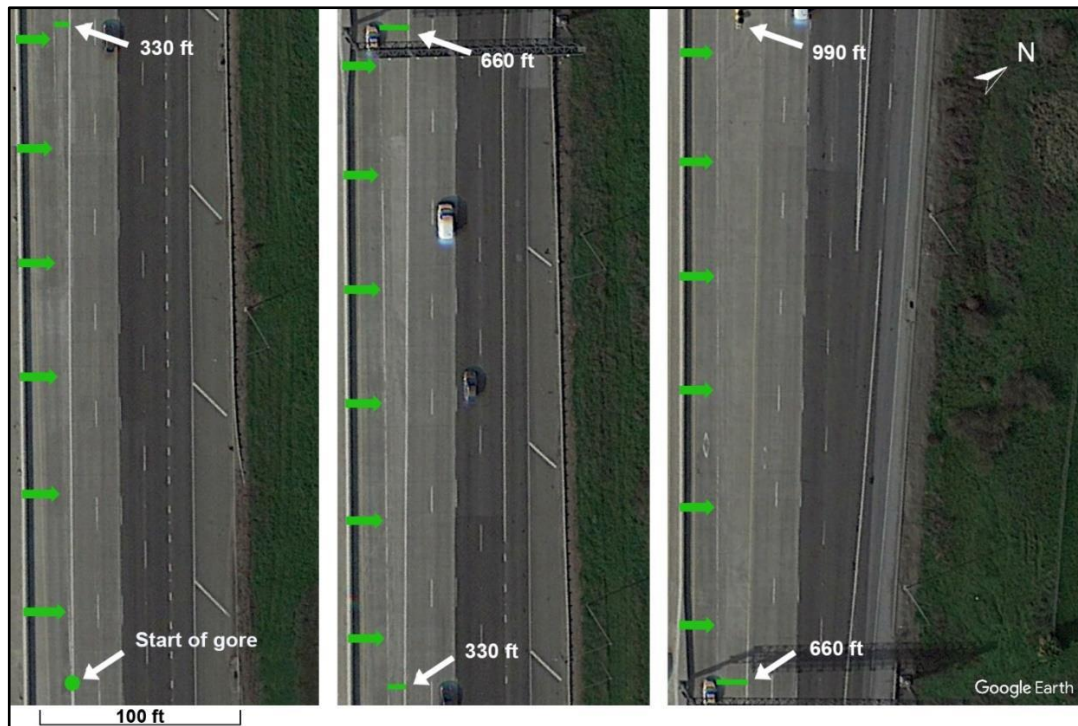
Figure 6. Depiction of gore lane lines, marked with green arrows: left edge line completely absent in initial third of gore (left image), and left edge line sporadic in middle (center image) and final third of gore (right image), with white arrows and measurements indicating distance from crash attenuator. (Source: Google Earth, depicting crash location on January 26, 2016)

Figure 6 also shows that the inside of the gore is not marked with optional diagonal cross-hatching or chevrons. According to section 3B.24 of the MUTCD, such markings may be used to discourage travel on certain paved areas, such as gores. As of March 2017, Caltrans had not delineated the inside of this gore. The state does not require marking gores with diagonal cross-hatching or chevrons.

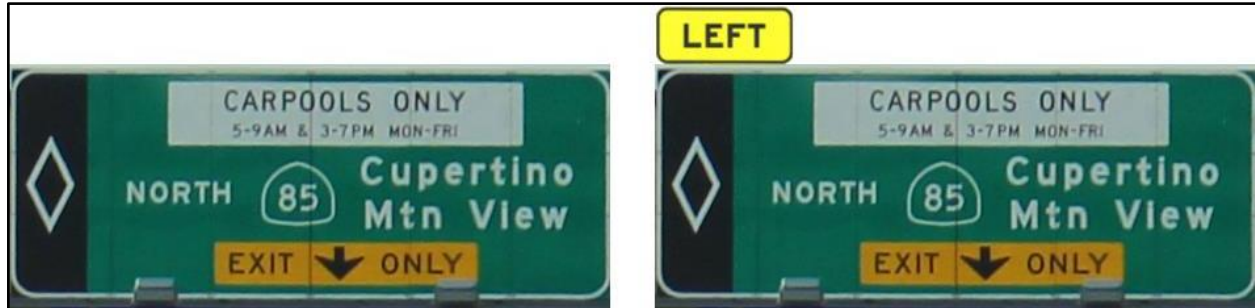
Figure 7. Noncompliant guide sign for left exit HOV lane for SR-85, located 0.5 mile in advance of crash attenuator (left); and example of compliant sign with left exit plaque (right).

The guide signs on approach to the crash location were out of compliance with the MUTCD requirement for left exit plaques (see figure 7). However, because these signs were placed before the FHWA ruling, they were not out of compliance with the requirement for a full border on top indicating a preferential lane. New signs without the full border indicating a preferential lane would be out of compliance for that MUTCD requirement.

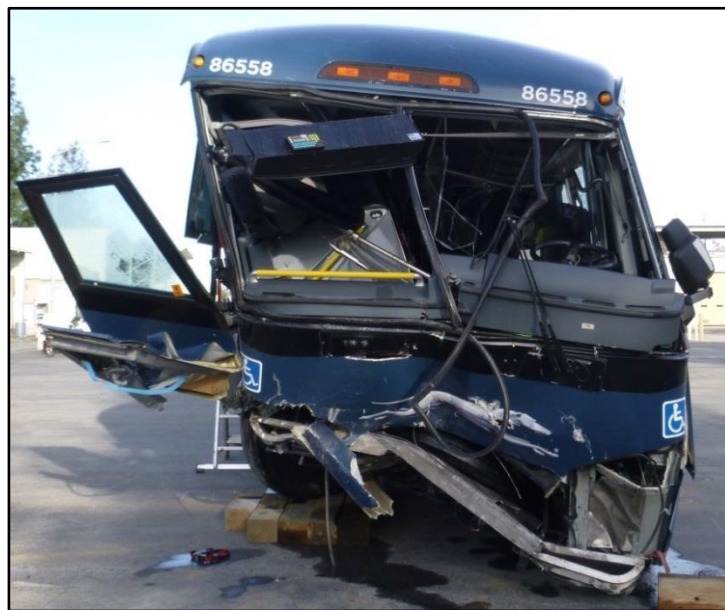
1.6.2.1 Exterior. As a result of the crash, the bus sustained contact damage to the front end, the undercarriage, and the right side, and induced damage to nearly all other areas. The initial impact with the crash attenuator and concrete barrier damaged the entire front end of the bus (see figure 8). The damage transitioned from the front to the undercarriage and into the right front wheel assembly, as noted below:

- Metal floor bracing was buckled vertically about 12.5 inches at the second row of seats.
- Front right wheel assembly was deformed rearward into the back of the wheel well.
- Entrance stairwell was crushed and shifted rearward 30 inches.
- Boarding door was partially attached and hanging from the door frame, with the bottom half of the door bent upward almost 180 degrees.

Figure 8. Bus postcrash, showing extensive frontal damage.

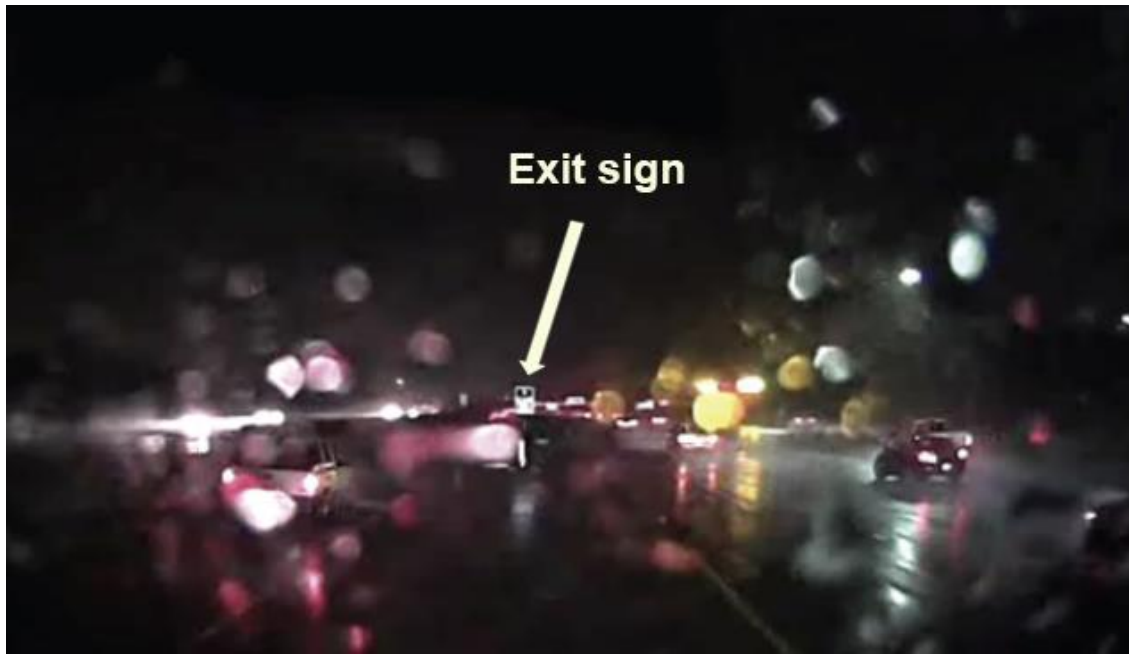
which are more salient than the lead cylinder of the crash attenuator (see figure 12).⁶² As such, the lead cylinder was unlikely to capture the driver's attention in time to avoid the crash, particularly considering his lack of expectation of a forward hazard.

Figure 12. Still image from forward-facing DriveCam video recording, captured 2 seconds before impact, with exit sign located behind last cylinder of crash attenuator.

The NTSB concludes that under the environmental conditions at the time of the crash, the crash attenuator without the retroreflective object marker on the lead cylinder could not have been perceived by the bus driver in time to avoid the crash.

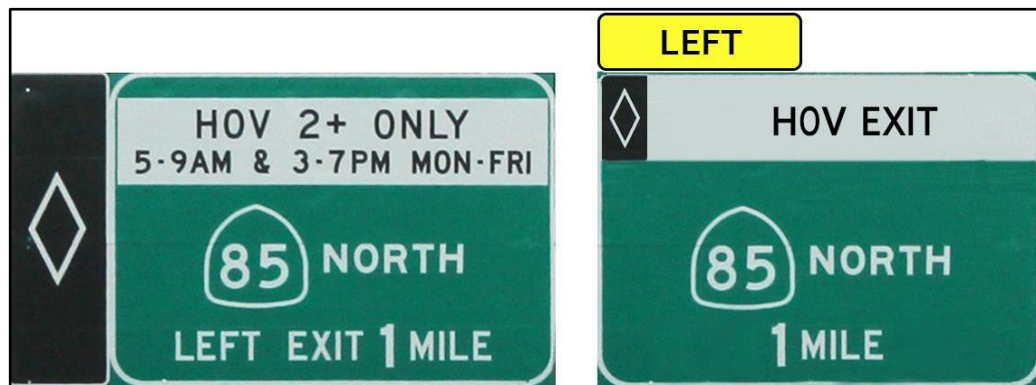
Figure 13. Sign for left exit HOV lane at crash location (left) and example compliant sign (right).

As of March 2017, Caltrans had not updated the sign for the left exit HOV lane at the crash location to comply with MUTCD guidelines. The NTSB concludes that had the sign for the left exit HOV lane for SR-85 been in compliance with the MUTCD, it would have provided the bus driver with improved traffic guidance and may have prevented the crash. Therefore, the NTSB recommends that Caltrans add the left exit plaque to the left exit sign at the crash location and to all left exit guide signs on California highways, as required by the FHWA.
